PRELIMINARY ASSESSMENT

**CES Environmental Services
Houston, Harris County, Texas
TXD008950461**

CES Environmental Services
4904 Griggs Road
Houston, Harris County, Texas
EPA ID TXDoo8950461

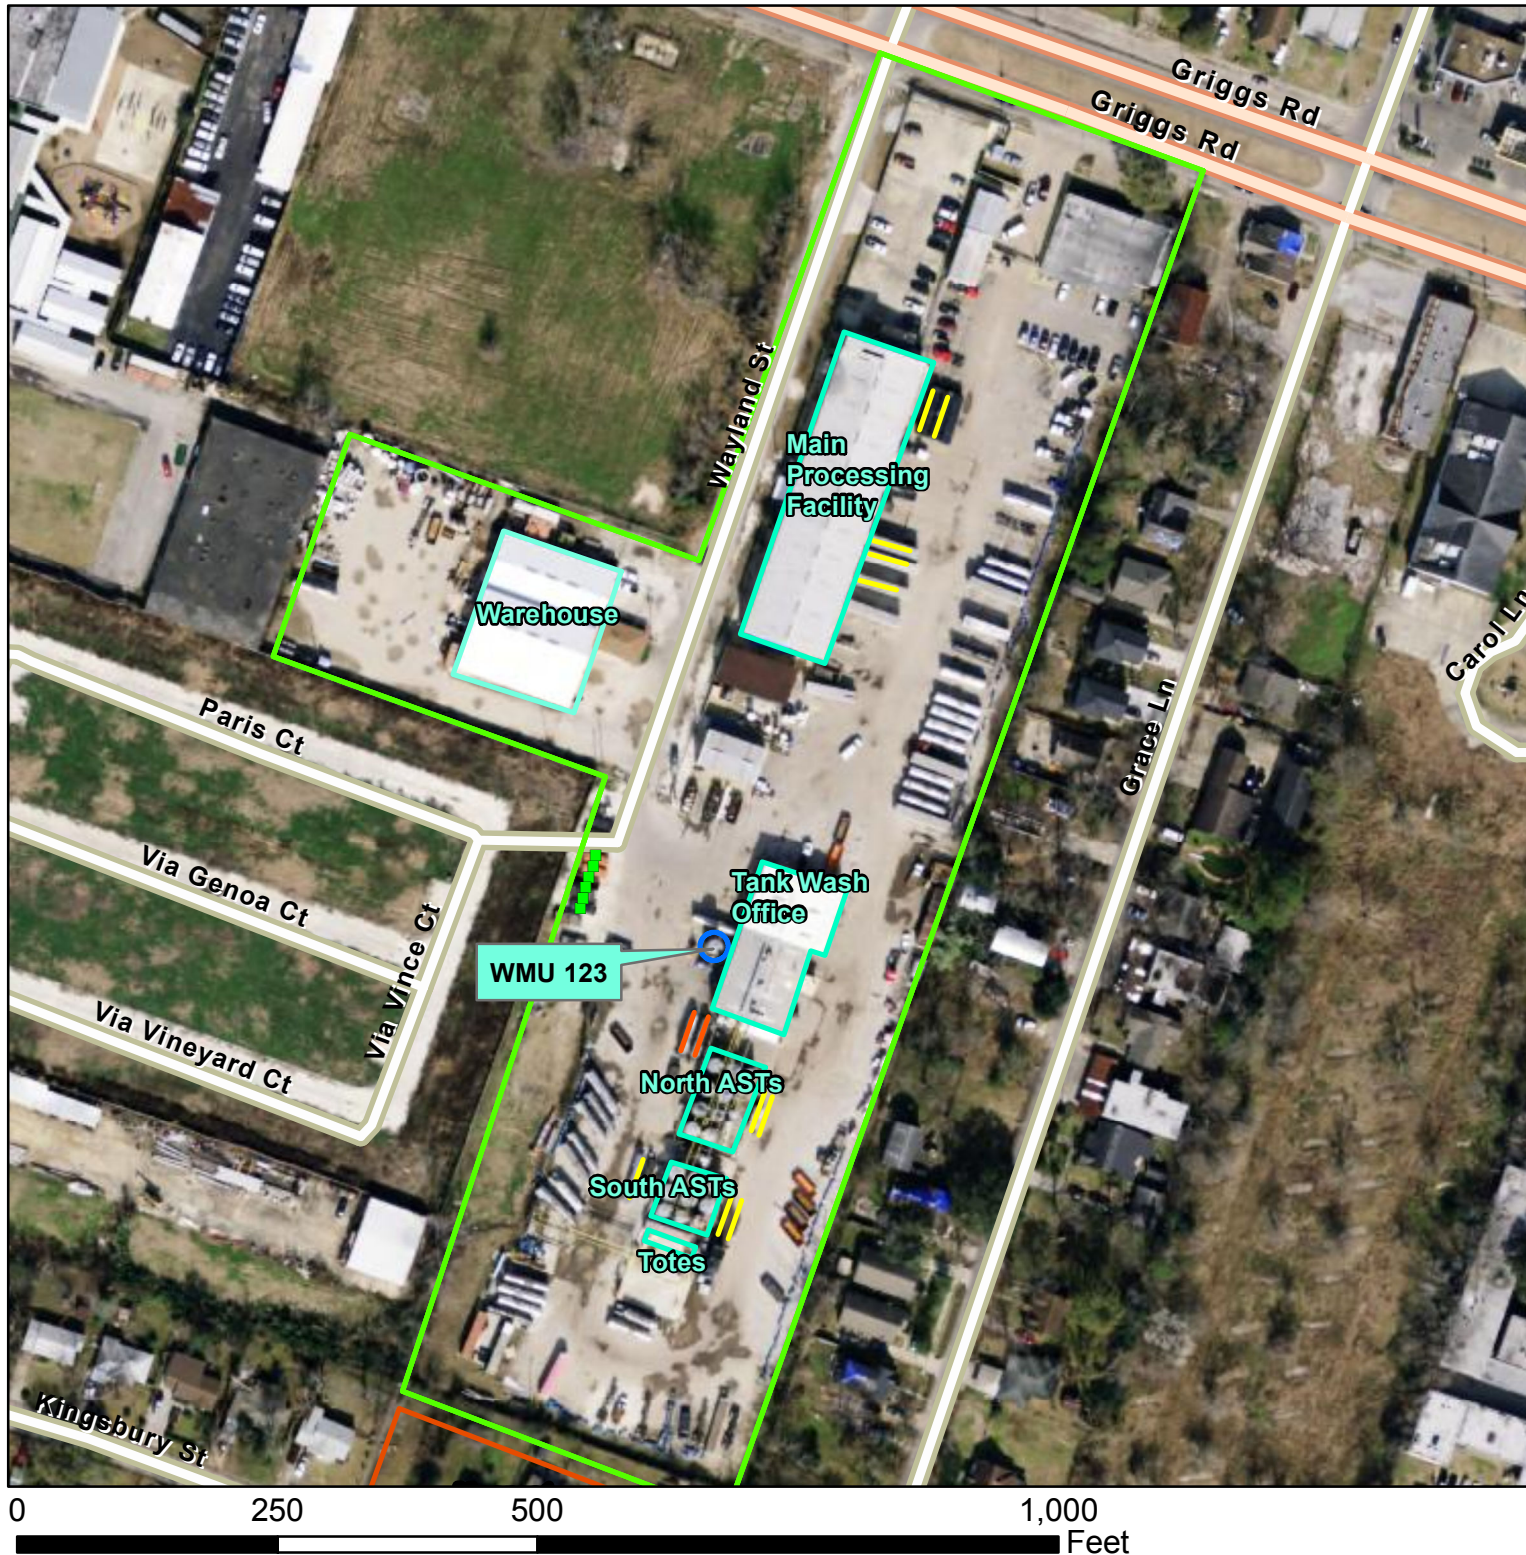
Figure 2: Site Features Map

Potential sources associated with the site include various chemicals contained within aboveground storage tanks, vats, totes, drums, frac tanks, roll-off boxes, vacuum boxes, tanker trailers, wastewater treatment tanks, and laboratory sampling containers. Contaminated soils, asphalt, and concrete are also potential sources (Figure 2).

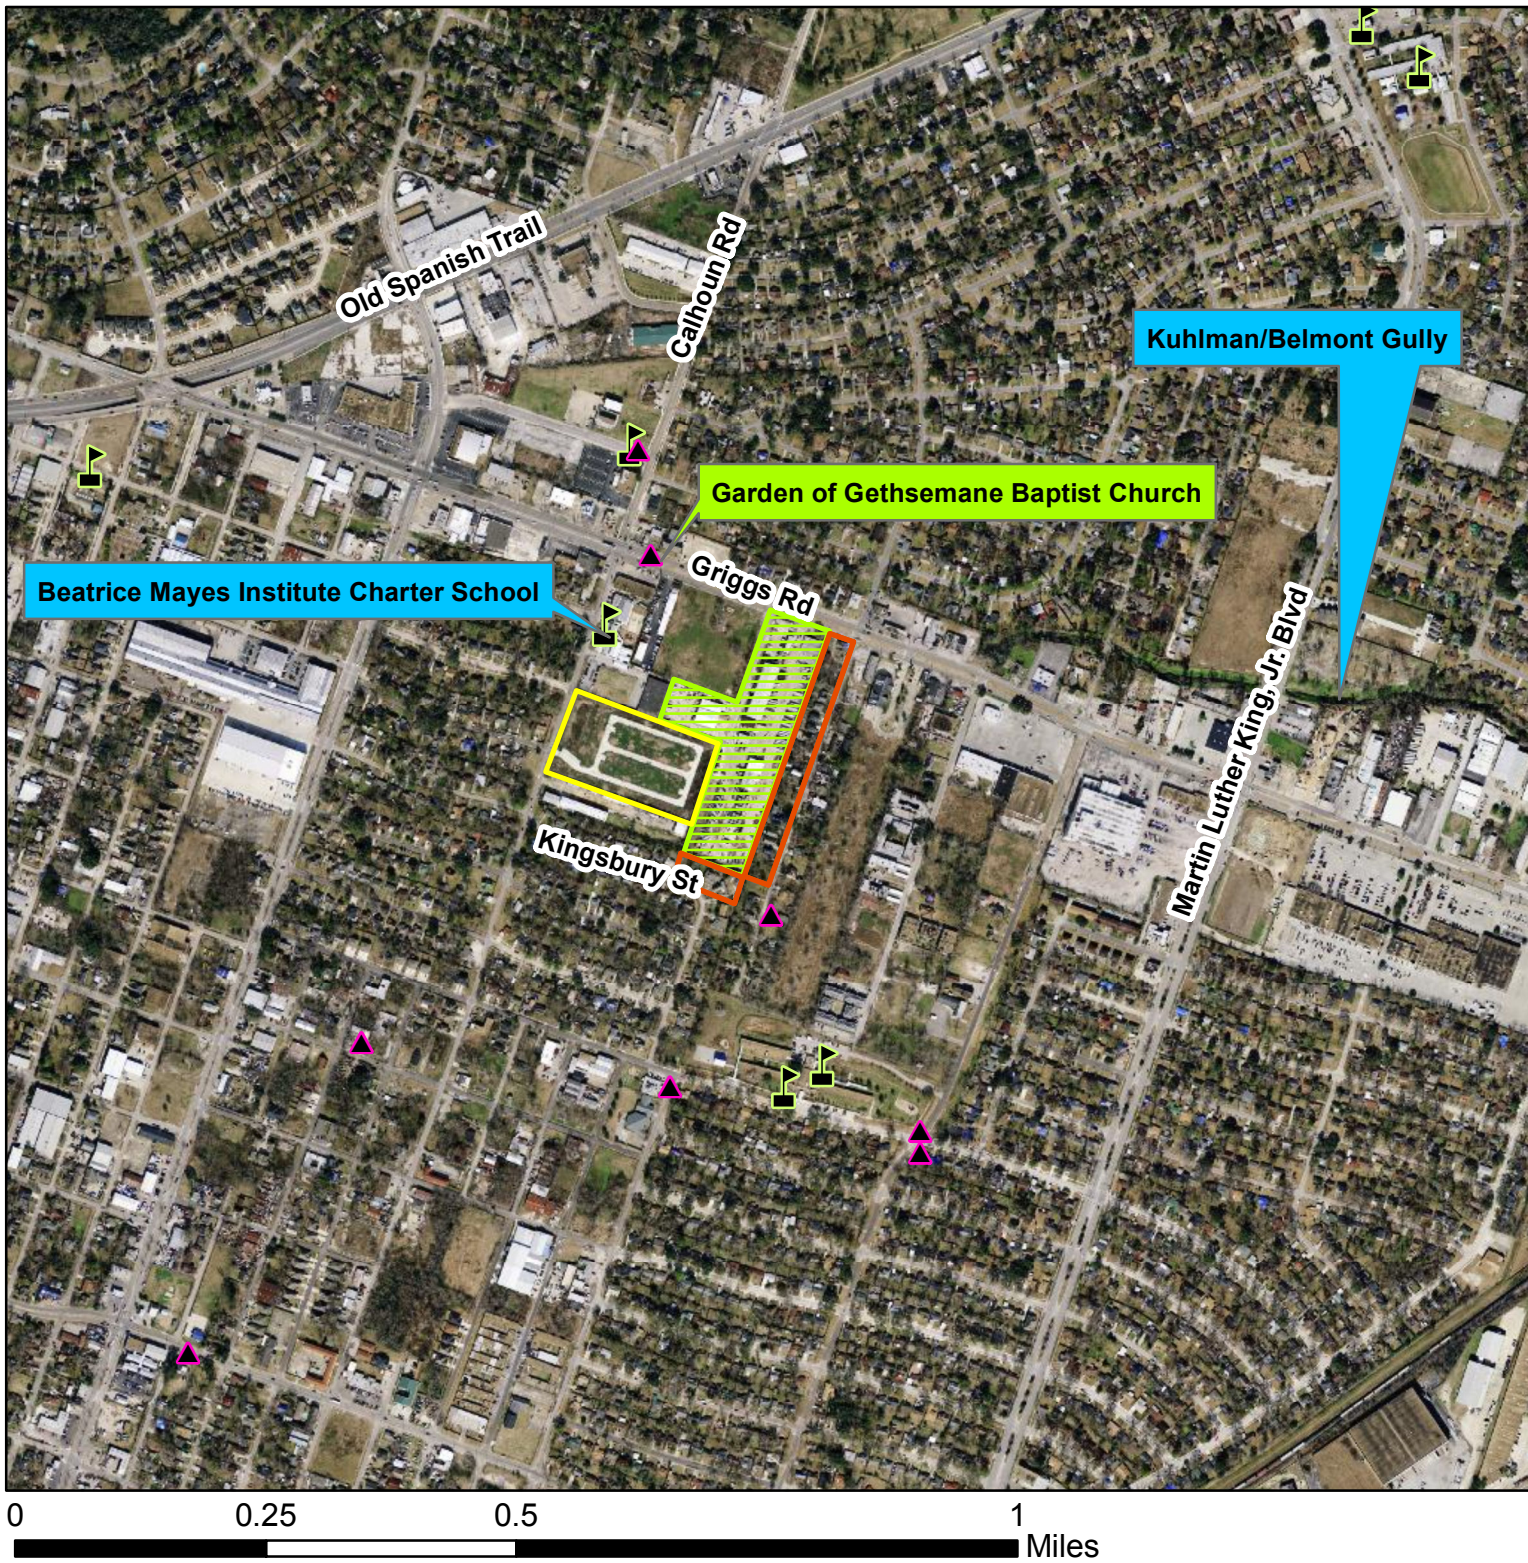
Figure 3: Site Proximity Features Map

The properties located immediately east and south of the site are residences (Figure 3). A few of the residences bordering the northeast corner of the site are currently abandoned (Ref. 5, p. 16). Griggs Road borders the site to the north, and other residences are present on the north side of the road. A vacant, open lot is located on the west side of Wayland Street, north of the on-site warehouse. The Beatrice Mayes Institute Charter School is located northwest of the on-site warehouse, adjacent to the vacant lot (Figure 3). The school uses the property located southwest of the on-site warehouse for physical education activities (Ref. 5, p. 2). This property is not currently considered part of the CES site; however, according to historical aerial photos, it appears to have been used for business operations associated with the site beginning at some point after 1943 and continuing until as recently as 2007 (Ref. 10, pp. 1-6).

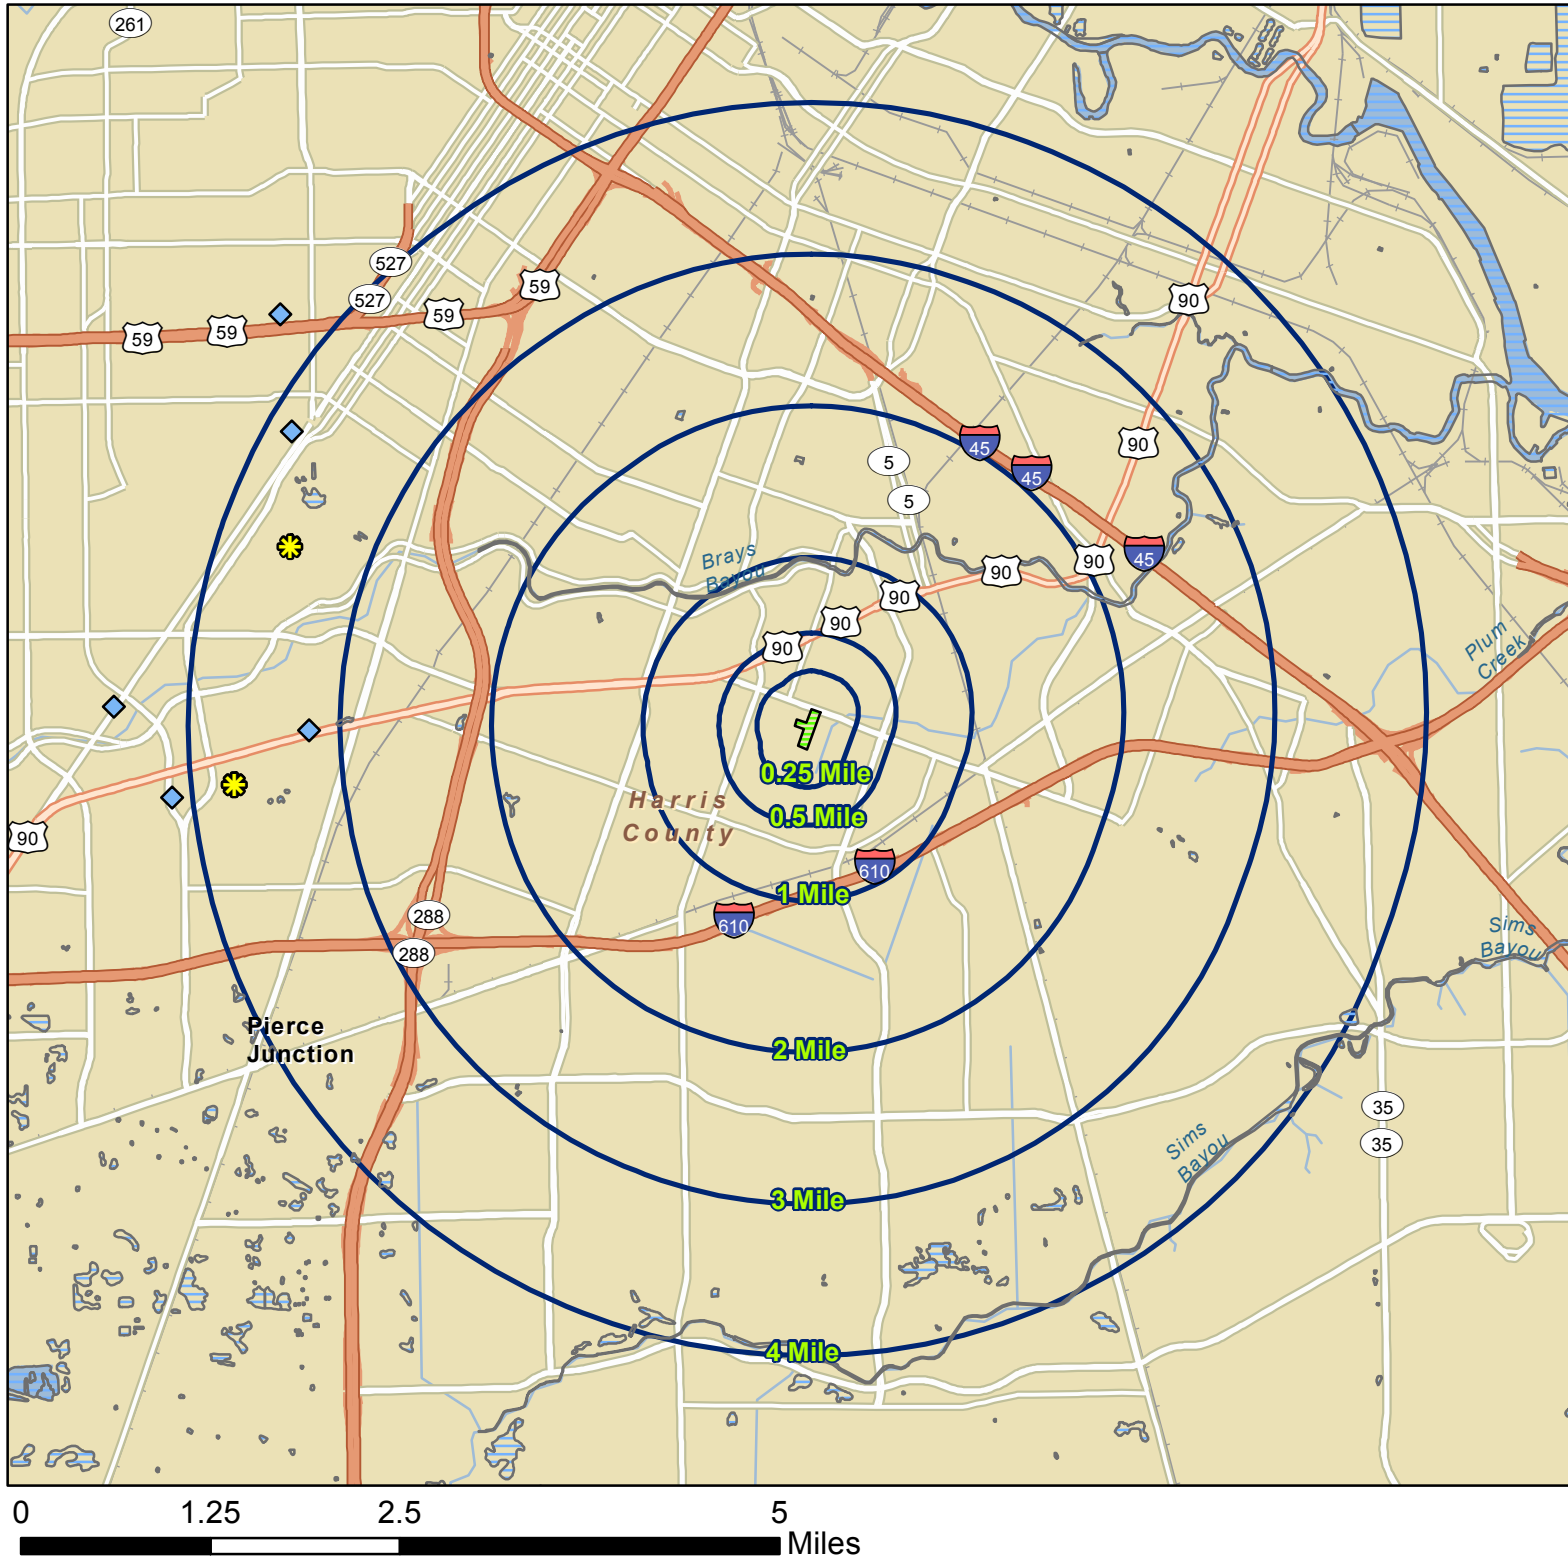
**Figure 4: 4-Mile
TDL Map**
CES Environmental
Services

The target distance limit (TDL) for the ground water migration pathway is a 4-mile radius that extends from the sources at the site. Figure 4 depicts the ground water 4-mile TDL.
